**MARINE INVESTIGATION REPORT
M02C0030**

SINKING AND LOSS OF LIFE

**AMPHIBIOUS PASSENGER VEHICLE *LADY DUCK*
OTTAWA RIVER
NEAR THE HULL MARINA
GATINEAU, QUEBEC
23 JUNE 2002**

Report Number M02C0030

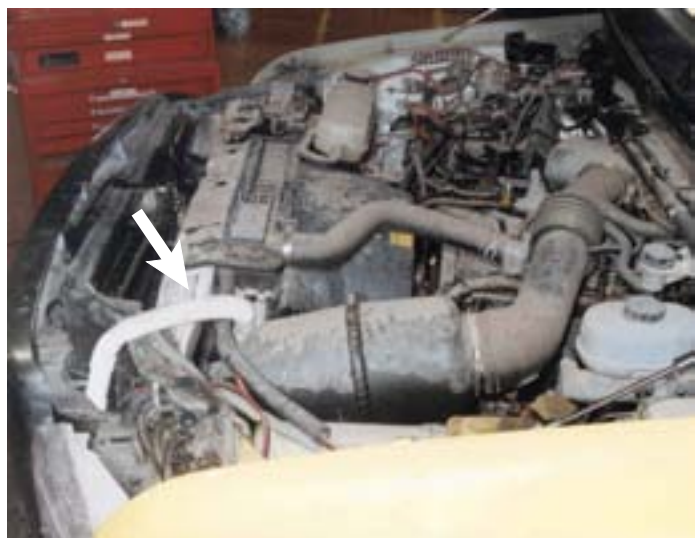
An electrically driven submersible bilge pump (Rule Mate 1100), incorporating a float switch, was located at the forward end of the forward engine compartment. The pump was actuated from a panel located below the steering column by a switch arranged with "automatic," "off" and "manual" settings. The manual switch was spring-loaded and must be held in that position by the driver for the pump to continue operating. A 25 mm-diameter (1-inch) flexible concertina-type discharge hose led up over the top and forward of the visor plate and the hood flexible gasket, some 460 mm (18 inches) above the load waterline. The hose extended some 200 mm (8 inches) below the load waterline at the front of the vehicle and was out of sight of the driver (see Photo 3). When the hood was closed, the discharge hose was compressed where it passed over the top of the forward sealing gasket, partially restricting the flow of any water issuing from the pump.

Photo 3. Discharge hose from the forward engine compartment

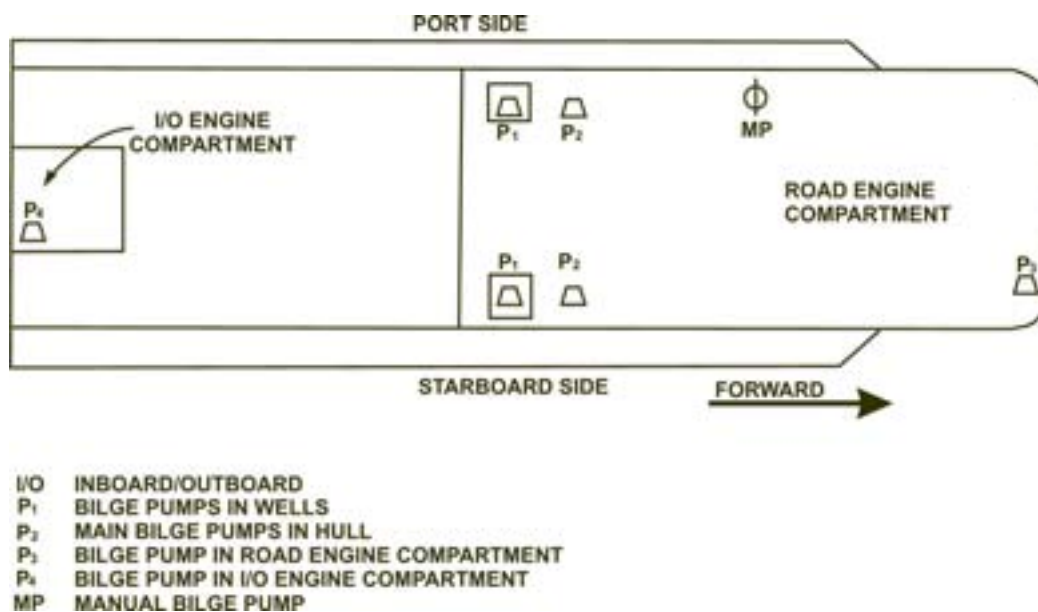
Figure 3 shows the location of the bilge pumps. Table 1 gives a summary description of the bilge pumps and outlines their status. See Appendix A for results of bilge pump examination and testing.

Figure 3. Bilge pump locations

Of the six electrically driven bilge pumps on board the vehicle at the time of the occurrence, two were found to be effectively operable. Actual discharge rates measured during the tests of the two emergency bilge pumps (Attwood V1250) that were operational were 335 US gal/h (21.2 L/min) each. This discharge rate was approximately 36 per cent of that specified for this pump model when operating at a comparable pressure head of 3.3 feet (1 m) with an electrical

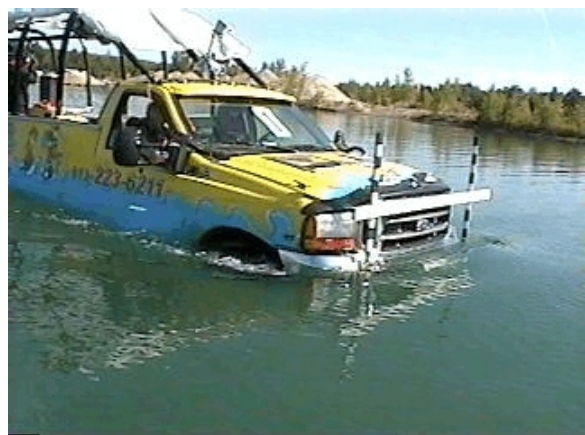
Trial speeds were progressively increased from 5 km/h up to a maximum of 10.25 km/h, and the related bow wave heights ranged from 90 mm (8½ inches) to in excess of 470 mm (18½ inches). At speeds up to about 5 km/h (see Photo 4), the bow waves were comparatively small. However, as the speed was increased, the bow waves became disproportionately higher and the initial effective visor freeboard of 470 mm (18½ inches) was significantly reduced.

Photo 4. Vehicle speed of approximately 5 km/h in calm water

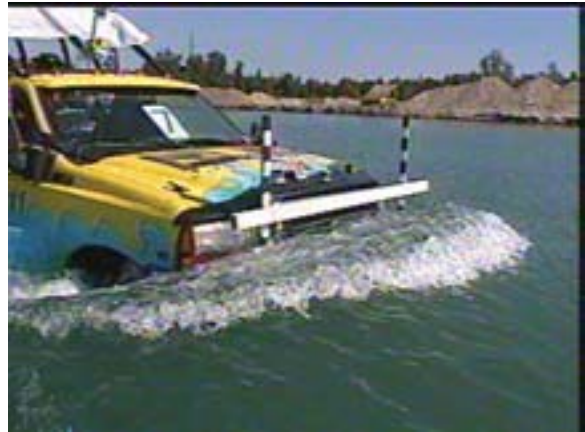
In calm water at a speed of 8 km/h, the bow wave was some 265 mm (10½ inches) high and the effective forward freeboard to the top of the visor was reduced to 205 mm (8 inches) (see Photo 5). At a speed of 9.85 km/h, the bow wave was level with the visor top (see Photo 6). At the maximum speed of 10.25 km/h, the bow wave partially covered the hood with water and heavy spray and overflowed the top of the forward visor. The configuration of the top of the forward visor and its attached gasket was ineffective in preventing entry of water through the space remaining between the top of the gasket and the underside of the hood.

Photo 5. Vehicle speed of approximately 8 km/h in calm water

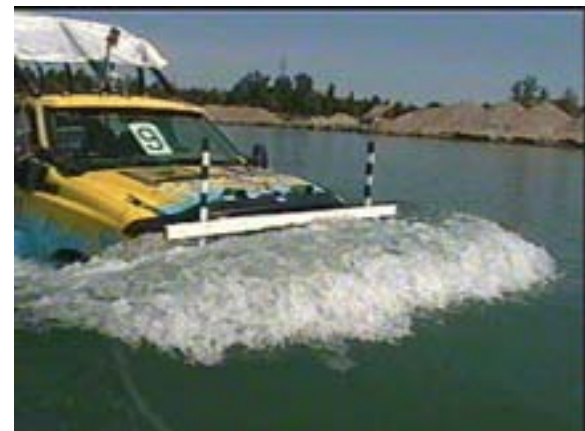
The temporary seals over the hood sides, engine ventilation openings, and forward cowl vents were effective. However, at speeds above 10 km/h, the floodwater continuously overflowed the visor top gasket and accumulated in the forward half of the vehicle. The volume of floodwater from this source was not determined due to the concurrent accumulation of water from the drive shaft bearing and hull leakage. The forward bilge pump and the two main bilge pumps were activated to clear the vehicle of all floodwater.

Photo 6. Vehicle speed of approximately 10 km/h in calm water

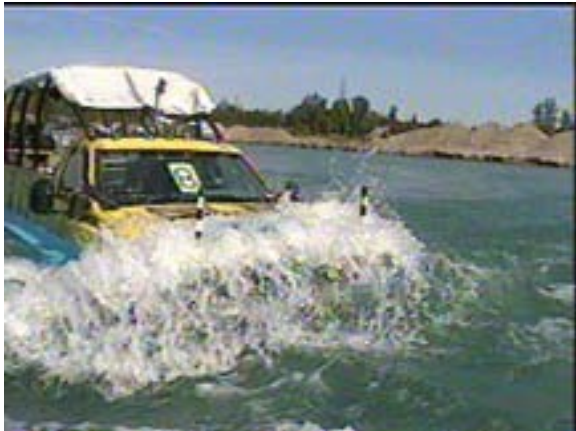
Significantly more floodwater was shipped and retained when in the unsealed condition. In disturbed water, at 8.3 km/h, water overflowed the top of the visor and also downflooded through the ventilator openings, forward cowls and hood sides (see Photo 7). At 9.75 km/h, the rate of downflooding increased considerably, water continuously overflowed the visor top, and a substantial quantity accumulated in the forward half of the hull (see Photo 8). The forward bilge pump, both main bilge pumps, and the two emergency bilge pumps were used to clear the vehicle of this accumulation.

Photo 7. Vehicle speed of 8.3 km/h in disturbed water

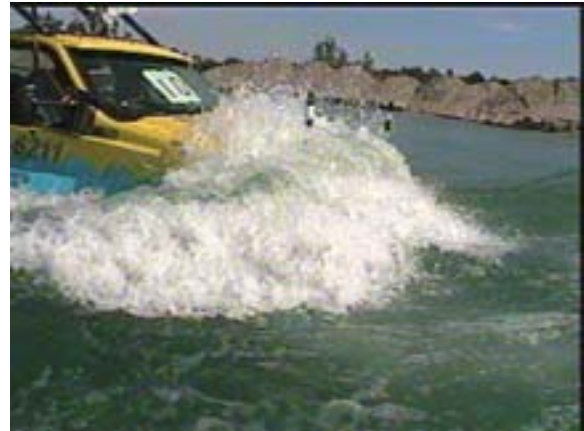
Photo 8. Vehicle speed of 9.75 km/h in disturbed water

In disturbed water conditions, heavy spray and some “solid” water covered the hood, causing significant downflooding through the ventilator openings, forward cowls and hood sides. However, the greatest ingress of water was from the front, past the hood front gasket and over the top of the forward visor plate, where the overflow took on a continuous waterfall effect. At 10.24 km/h, the rate of downflooding and rapid accumulation of water in the forward half of the vehicle was such that it was considered imprudent to continue at this speed for the time needed to complete the trial without the operation of all bilge pumps forward of midships.

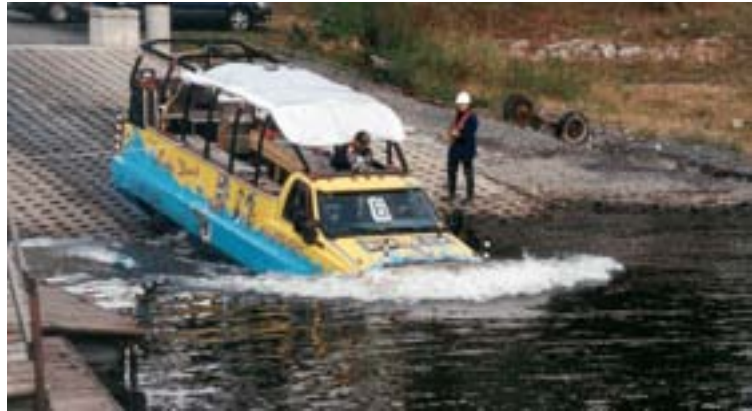
When the vehicle was launched at 8 km/h with all temporary seals removed from the hood, the visor was just submerged, the hood briefly awash and 22 litres of water was shipped (see Photo 9). When the vehicle was launched at 10 km/h, the visor was submerged approximately 80 mm (3¼ inches), the hood and windshield were fully awash, and 32 litres of water was shipped on board.

Photo 9. Vehicle launched at 8 km/h, visor submerged by approximately 25 mm

With the vehicle in a fully loaded condition, ramp launching speeds in excess of 8 km/h resulted in a significant quantity of water being shipped. In service, and in the absence of bilge high level alarms, the actual quantity of water shipped at the beginning of each tour would not be known by the operator, and its discharge was dependent on the prompt operation of the forward bilge pump.

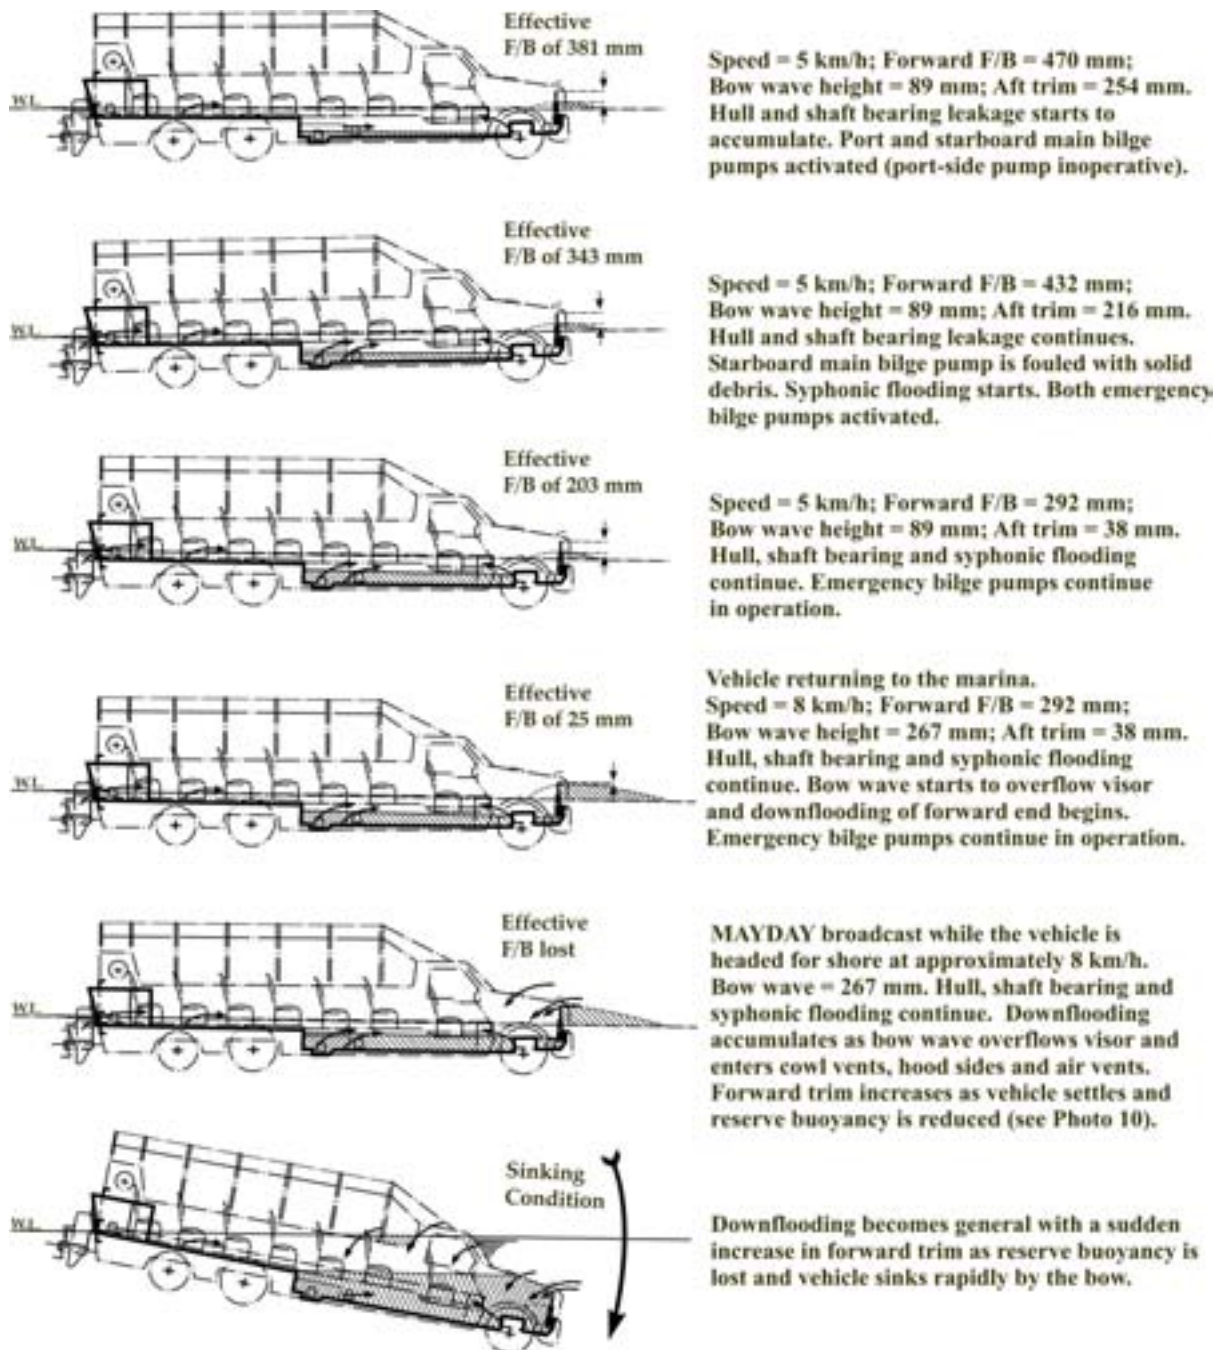
The forward bilge pump, which was best situated to cope with an accumulation of water in the front of the vehicle, was inoperative and the emergency bilge pumps near midships did not stem the total inflow. As the vehicle was headed toward the Hull Marina, the water accumulated in the forward end of the hull and the vehicle continued to trim more and more by the bow, causing the rate of the downflooding to accelerate. This cycle continued until forward reserve buoyancy was lost and the vehicle suddenly sank bow first.

Figure 4. Sinking sequence

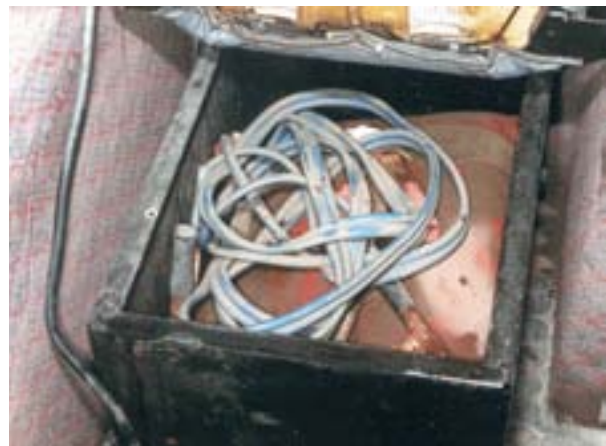
The adult lifejackets were stowed in lockers under each of the passenger seats. Examination after the occurrence revealed that it was not easy to remove the lifejackets from beneath the seats, as they tended to catch on the lip of the

Photo 11. Lifejacket under the seat with booster cables on top

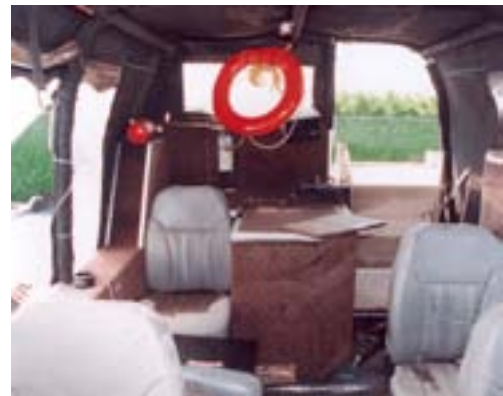
When the passengers boarded, they did so through a boarding ramp on the rear left corner of the vehicle. After all passengers boarded, the ramp was folded up by an electric winch into an opening of 1830 mm high by 685 mm wide (72 inches high by 27 inches wide) that forms a watertight seal for operation in the water. Once the ramp was secured, the opening, which was also an exit in the event of abandonment, was reduced to 788 mm high (31 inches) and 685 mm wide (27 inches) at its widest point, decreasing in width to 533 mm (21 inches) near the top of the exit (see Photo 12).

Photo 12. View from inside the vehicle of rear exit with boarding ramp in retracted position

To access this rear exit for emergency egress, passengers had to make their way along a 584 mm-wide (23-inch) aisle and then make two turns to move between the rearmost seat on the port side and the front left side of the I/O engine compartment. The narrowest point of this route was 514 mm (20¼ inches). Once at the exit, passengers had to climb approximately 1016 mm (40 inches), with no permanent foothold to aid them, to the top of the retractable stairs to reach the available opening. There were several sharp metal corners on the top of the retractable staircase and winch assembly. The two bottom stairs of the ramp folded upside down against the exterior of the vehicle; the first of the two presented an almost slide-like property to anyone attempting to egress through this exit. Once passengers were at the top of the retractable stairs, there was no platform to step onto to facilitate egress into the water. Passengers had to find a posture to jump without any support structure to aid them in that movement, while ensuring that they cleared the hazard presented by the exterior stairs and the I/O motor.

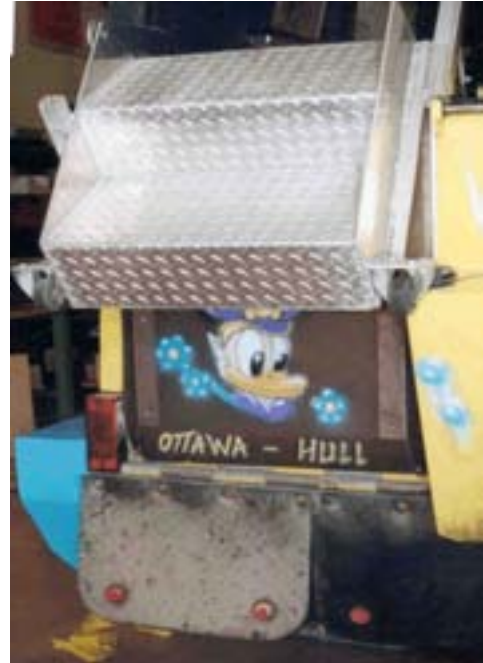
The ramp was articulated in that, when the ramp was retracted, its bottom two stairs folded upside down against the exterior of the vehicle. Once the vehicle was in the water, the boarding ramp could not be lowered (see Photo 13).

Photo 13. After boarding ramp in retracted position
