**MARINE INVESTIGATION REPORT
M02C0030**

SINKING AND LOSS OF LIFE

**AMPHIBIOUS PASSENGER VEHICLE *LADY DUCK*
OTTAWA RIVER
NEAR THE HULL MARINA
GATINEAU, QUEBEC
23 JUNE 2002**

Report Number M02C0030

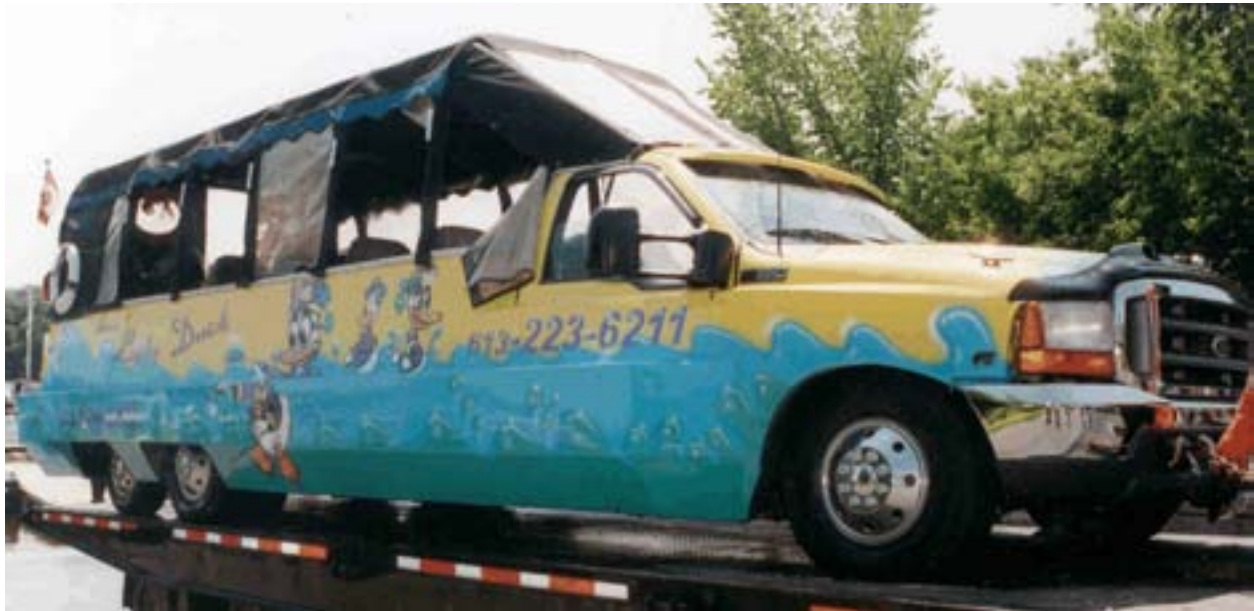
The vehicle was based on the conversion of a Ford F-350 truck chassis (see Photo 1). The original gasoline engine was used for on-road operation. A gasoline-powered Mercruiser inboard/outboard (I/O) motor at the rear was used for water-borne propulsion. Figure 1 shows the basic layout of the vehicle.

Photo 1. Lady Duck after recovery at the Hull Marina

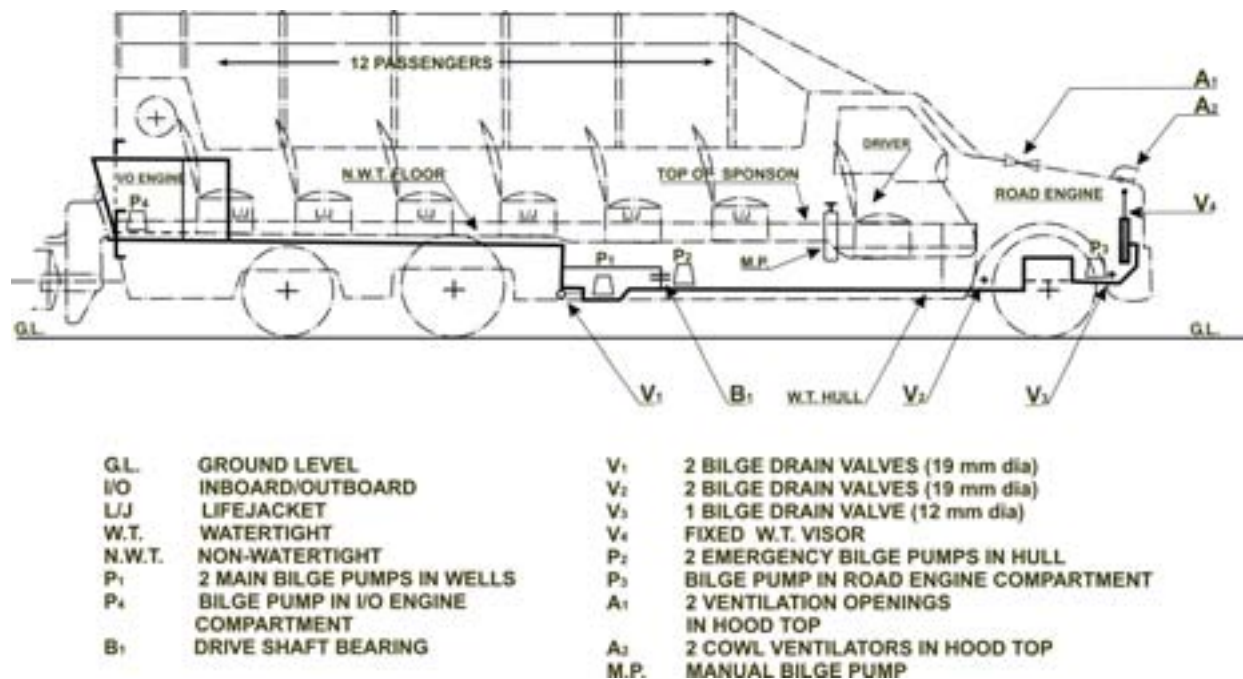
Figure 1. Construction profile outline

The vehicle was fitted with five drainage points, each comprised of a hand-operated, ball check valve (seacock) with a swing-check, non-return valve immediately inboard, both of which were mounted on a common pipe spigot and closed with a screwed steel plug. Four of the drainage points were 19 mm ($\frac{3}{4}$ inch) in diameter; the fifth was 12 mm ($\frac{1}{2}$ inch) in diameter. Once on shore, the drainage points could be used to release accumulated water from the bilges (see Figure 1).

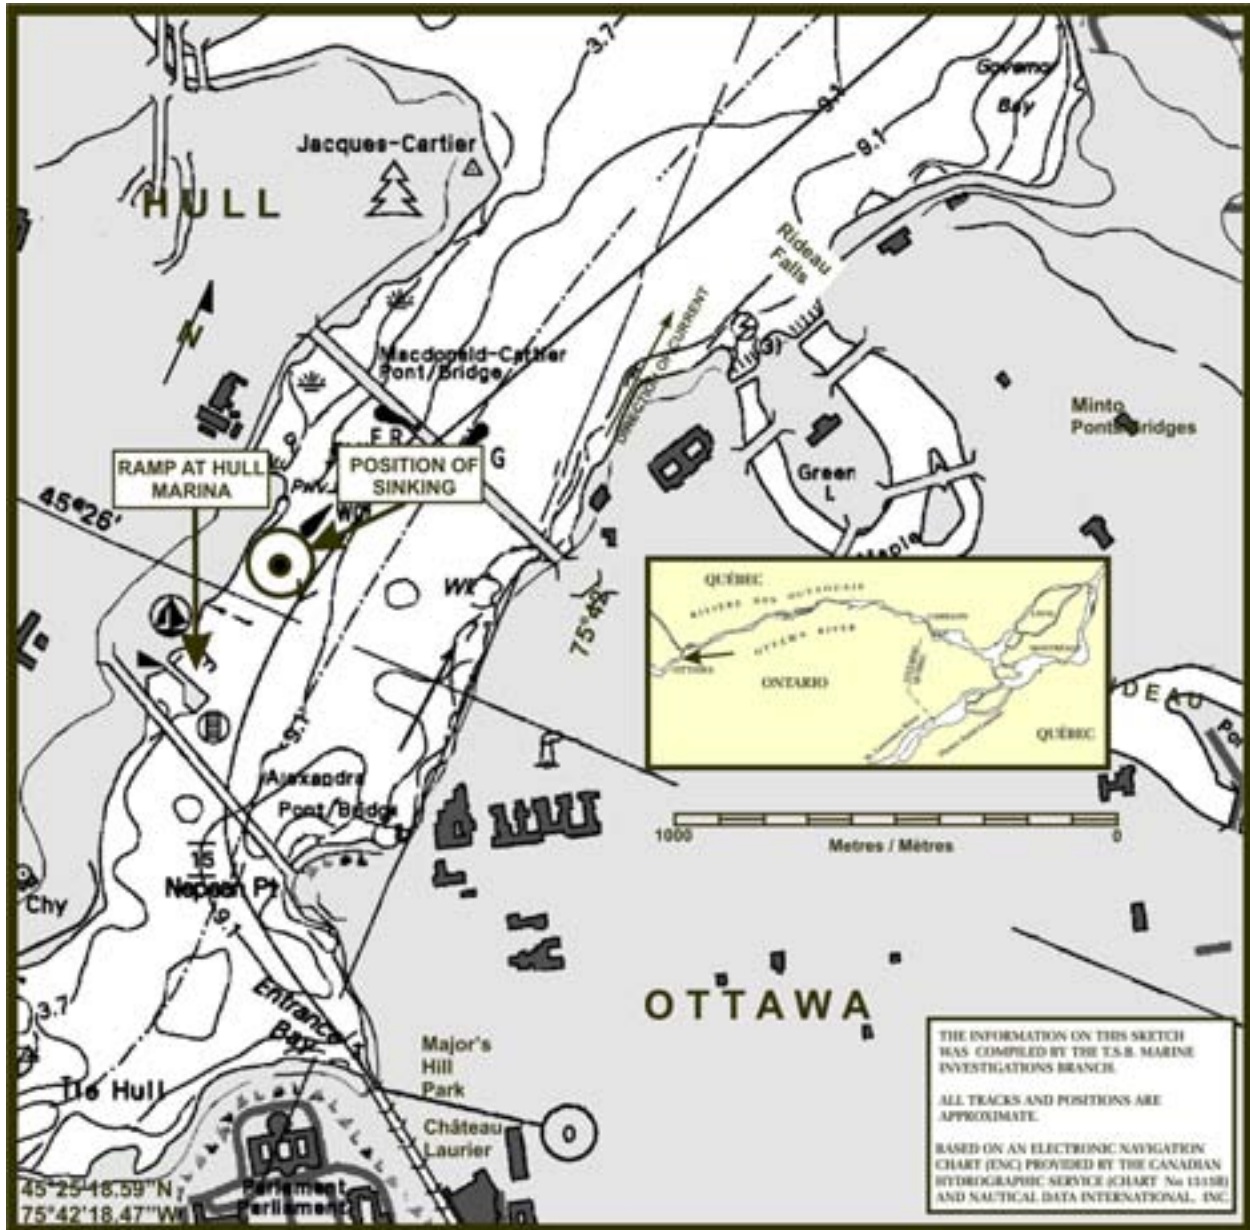
Figure 2. Chart of the occurrence area

The forward trim continued to increase and, realizing that the safety of the passengers was at risk, the driver instructed the tour guide to tell the passengers to don PFDs. At this time, he diverted the vehicle toward the nearest point on the Quebec shore. The driver then broadcast a MAYDAY on emergency VHF channel 16, identifying the *Lady Duck*, giving its position and the number of passengers on board. At about 1610, the situation deteriorated rapidly as more floodwater accumulated in the forward end of the vehicle. The driver then called on the passengers to abandon the sinking vehicle. The driver left the steering position, made his way aft and, with seven other persons, managed to get free of the sinking vehicle. The remaining four passengers became trapped under the fabric awning and sank with the vehicle in 8 m of water.
